Phase 1 Inspection Report: National Dam Safety Program. Mississippi - Kaskaskia - St. Louis Basin. Lake Adelle Dam, Jefferson County, Missouri

LAKE ADELLE DAM
JEFFERSON COUNTY, MISSOURI
MO 30411

PHASE 1 INSPECTION REPORT NATIONAL DAM SAFETY PROGRAM

Name Of Dam:	Lake Adelle Dam
State Located:	Missouri
Inventory Number:	MO 30411
County Located:	Jefferson County
Stream:	Unnamed Tributary to Skullbones Creek
Date of Inspection:	25 February 1981

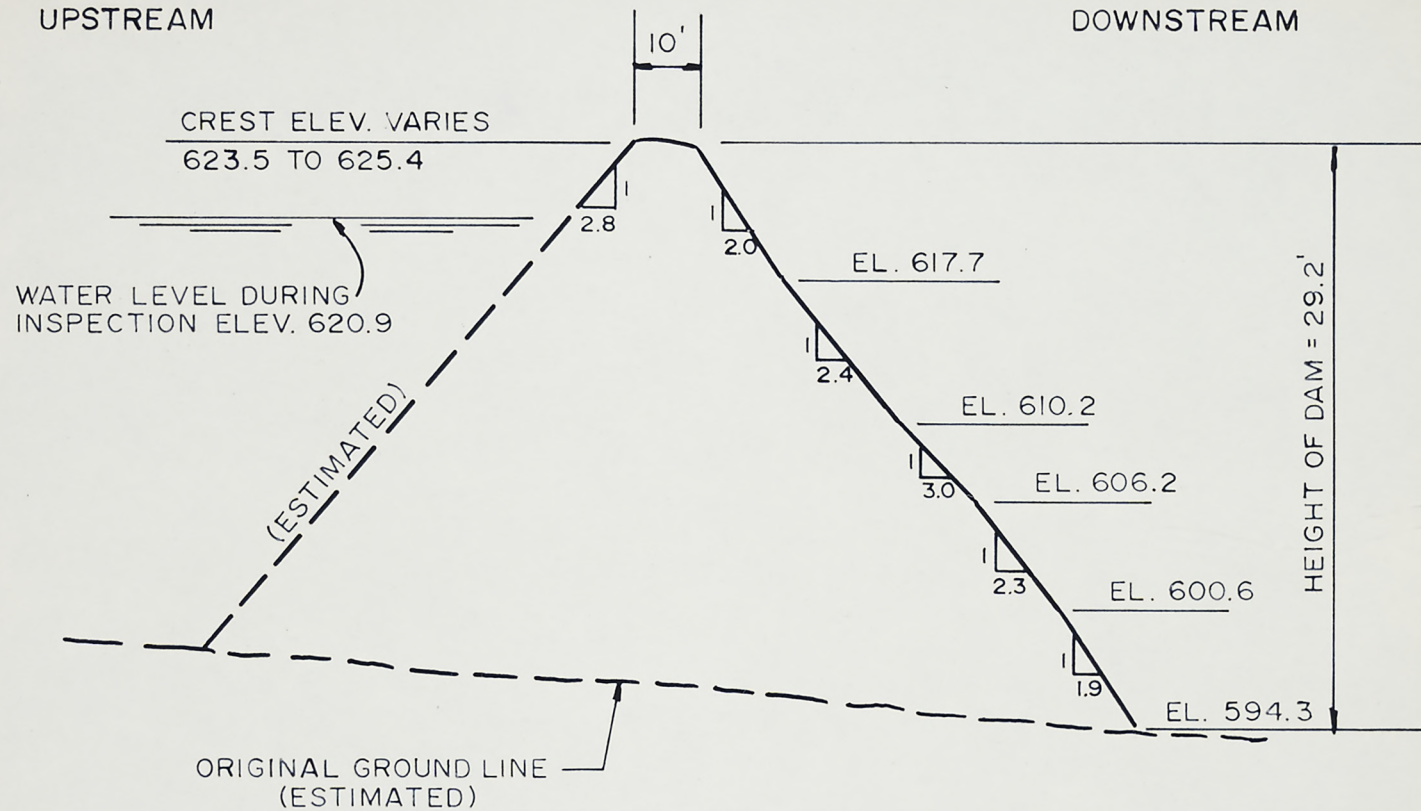
TYPICAL CROSS SECTION OF DAM

The downstream face of the dam had a slope which varied from about 1.9 horizontal to 1 vertical to about 3.0 horizontal to 1 vertical and also had a rather irregular surface. A typical cross section of the dam can be seen on Plate 5 of Appendix A. The downstream face of the dam was generally irregular. The exact cause for the variation in slope and the surface irregularity could not be determined but did not appear to be the result of sloughing and was probably the result of the original construction and some erosion. The variation in slope and the surface irregularity did not appear to be related to the variations in the dam crest elevations. The downstream face had a heavy brush cover and had several trees on it. There were several piles of brush and branches as a result of clearing which was reported to have taken place in the previous year. The heavy brush inhibited a thorough inspection of the downstream face. Two views of the downstream face are given on Photographs 4 and 5.

The steep and irregular slopes of the downstream face present a condition that may contribute to instability. It should be noted that Lake Adelle Dam is located in Seismic Zone 2 as shown on Plate 3 of Appendix A. A Seismic Zone 2 delineates areas in which moderate damage would result from the expected seismic activity in the area. The lack of seepage and stability analyses is a deficiency which should be corrected. Seepage and stability analyses should include an allowance for seismic loadings.

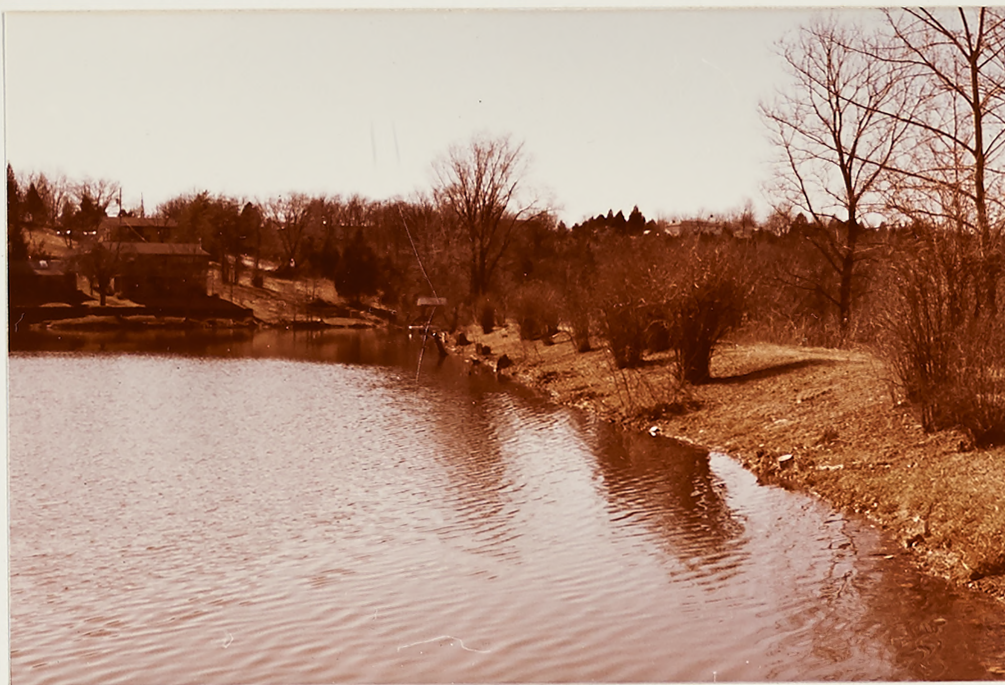
The upstream face of the dam had a slope of approximately 2.8 horizontal to 1 vertical. The upstream face had several trees, bushes, and tree stumps on it. According to Mr. Doug Halbert, the tree stumps were left from trees which had been cut down in the past two years. The upstream face of the dam had a grass cover which had been kept mowed. Erosion from wave action on the upstream face of the dam was minimal, indicating that the absence of riprap or other slope protection near the normal pool level is not a deficiency. Some scattered pieces of limestone were noted along the water's edge just below the waterline. These pieces of rock were apparently part of the fill and had been exposed by washing of the surface soil. A view of the upstream face is given in Photograph 2.

Photograph 2. Upstream face of dam viewed from the right abutment.

1. The brush and bushes should be removed from the embankment. All disturbed areas should be repaired and reseeded.
2. The trees and brush in the spillway channel should be removed and the channel kept free of obstructions.

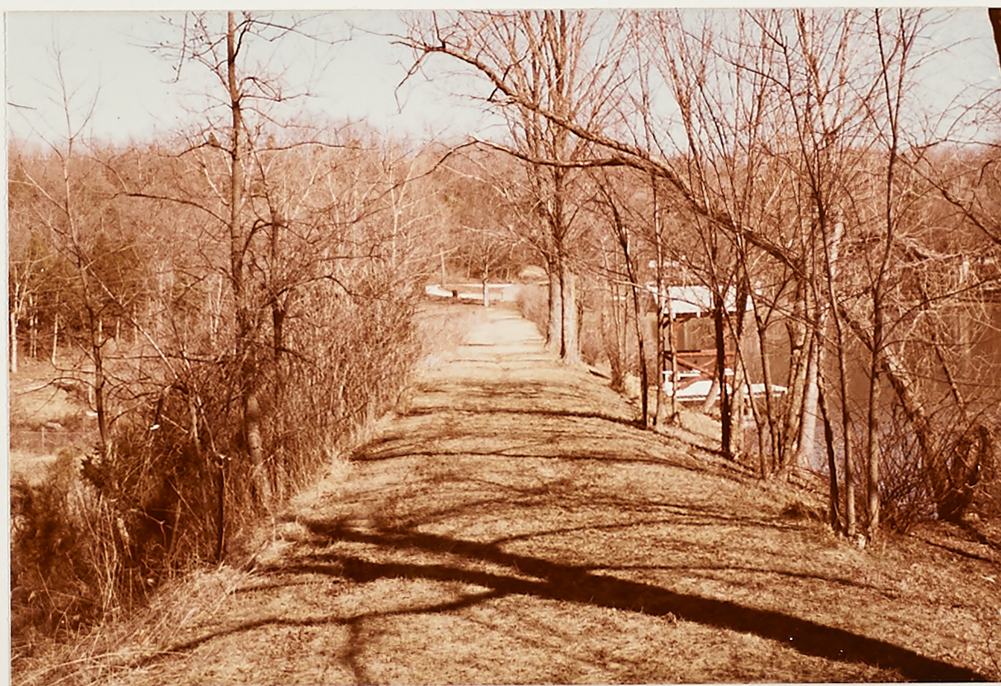
Photograph 3. Crest of dam viewed from the left abutment.

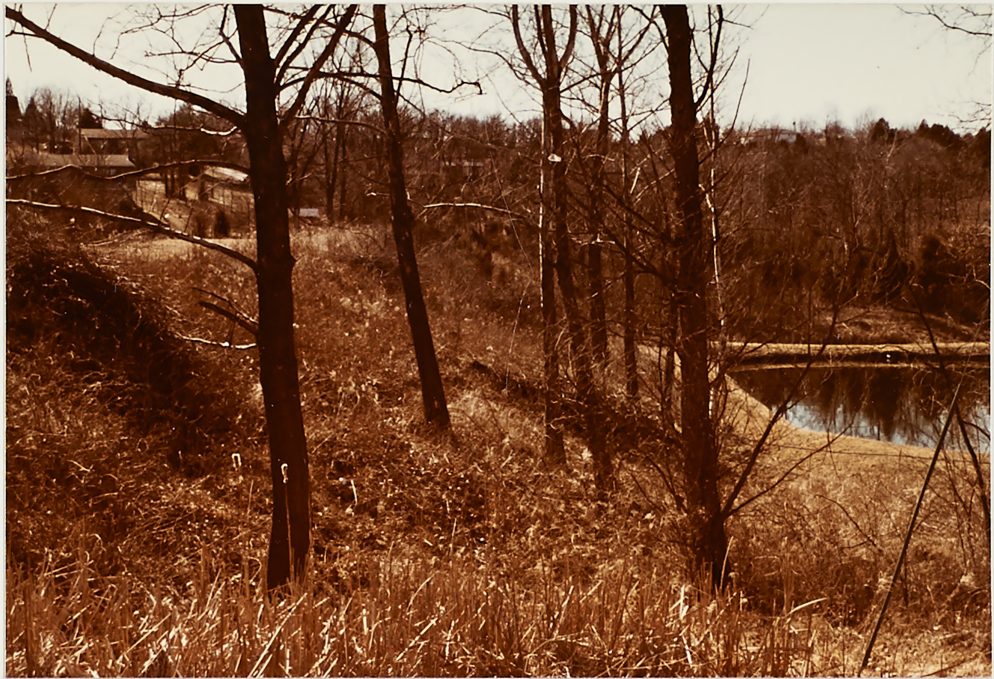
Photograph 4. Downstream face of dam viewed from the right abutment.

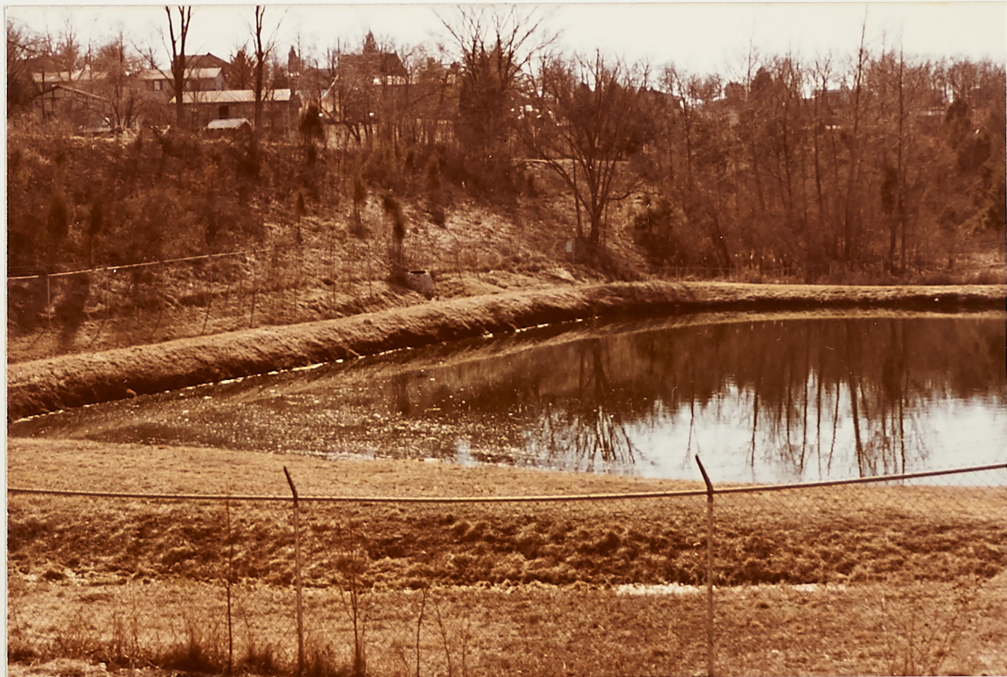
Photograph 5. Downstream face of dam and one cell of the sewage lagoon.

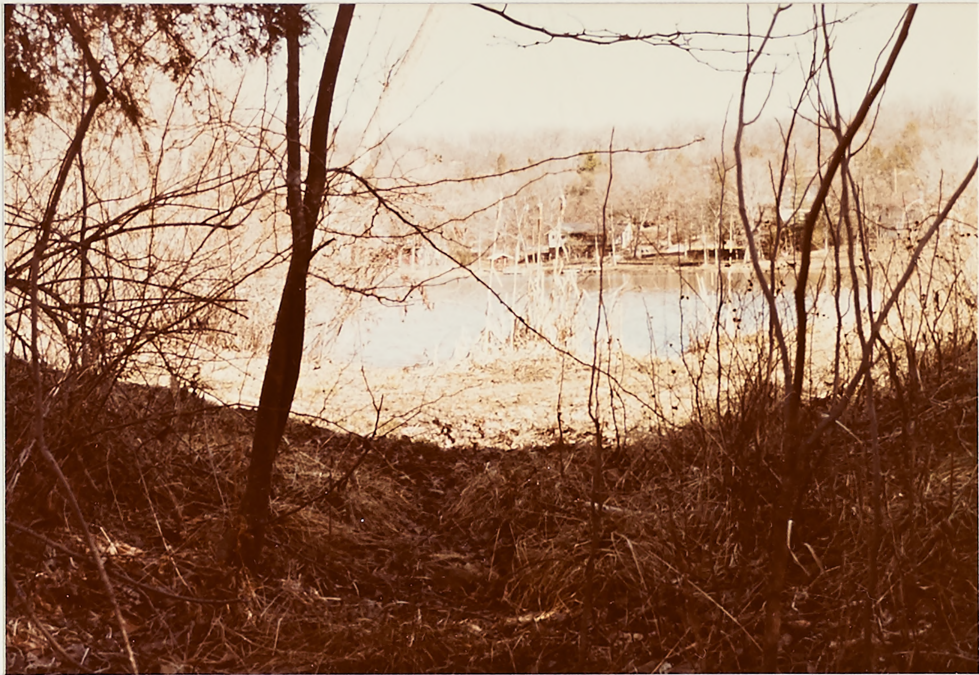
Photograph 6. Looking upstream at the spillway approach channel from the spillway crest.

The brush and small trees in the spillway channel should be cleared and should be replaced with a suitable vegetal cover which will minimize scour and erosion in the channel but which will be less restrictive to the flow.

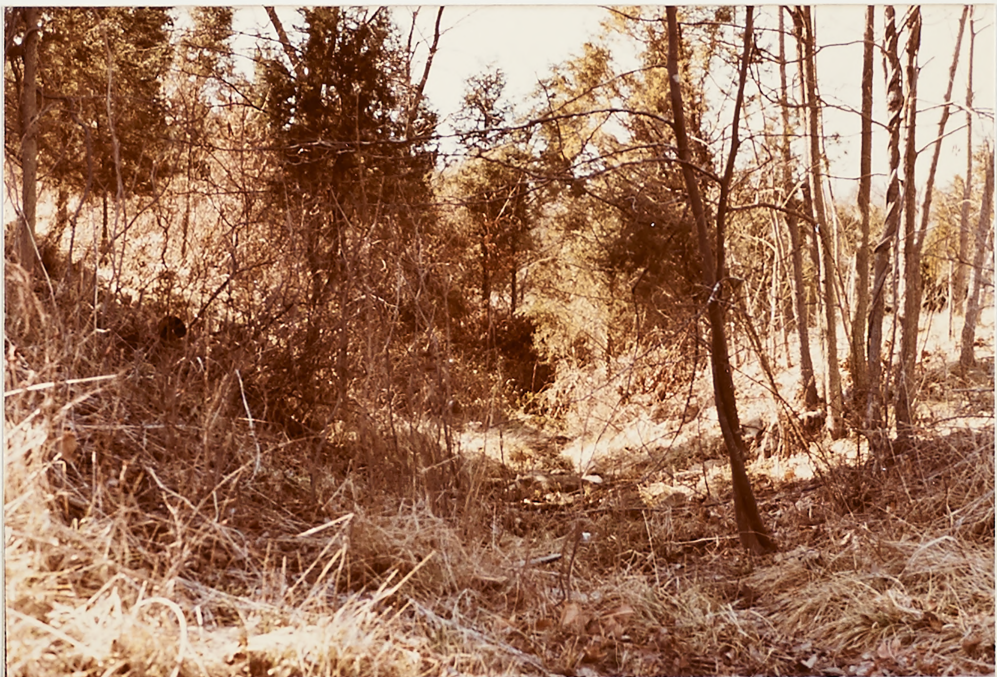
Photograph 7. Looking downstream at spillway channel from approach channel.

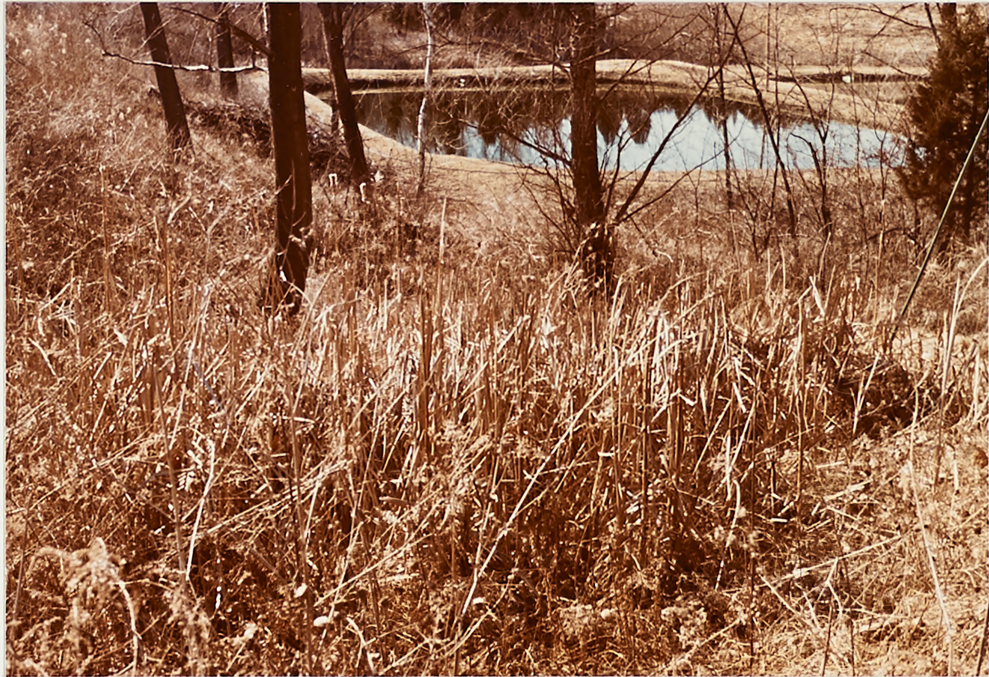
There were cattails growing at the downstream right abutment and just beyond the toe of the dam at the left abutment. The cattails indicated that those areas have had standing water or have been damp most of the time. A small amount of standing water was seen at the right abutment and the ground was damp and soft in the area where the cattails were located. This water was clear and was not observed to be flowing. The wet area may have been the result of exfiltration from the sewer which runs from the manhole near the right abutment to the sewage lagoons. A view of the cattails at the right abutment is given in Photograph 8.

Photograph 8. View of cattails at downstream right abutment.

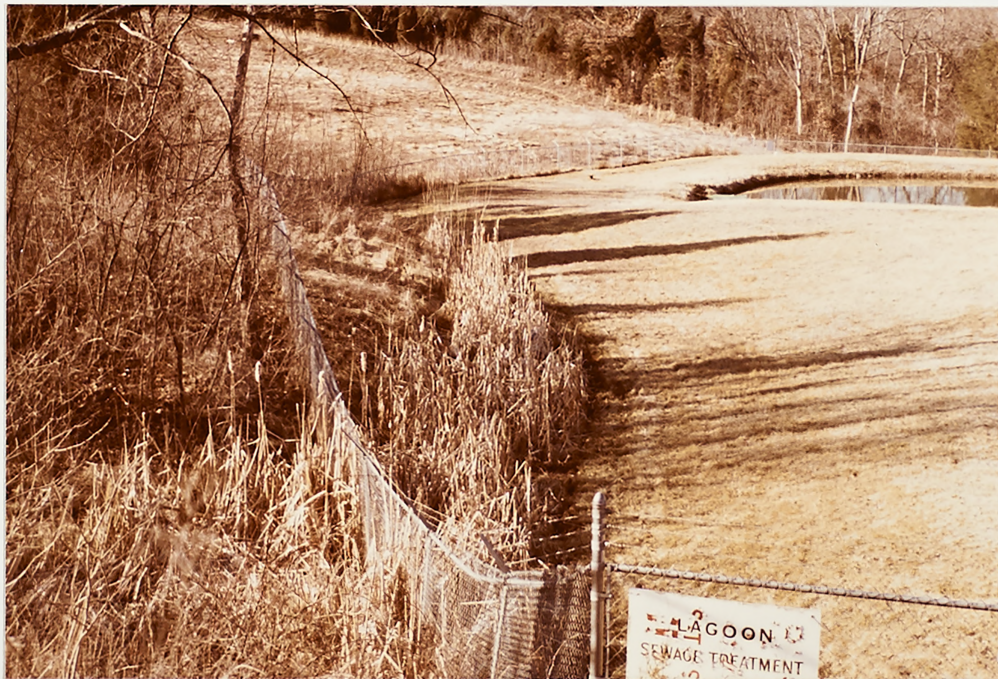
Photograph 9. Cattails beyond the toe of the dam at the left abutment.

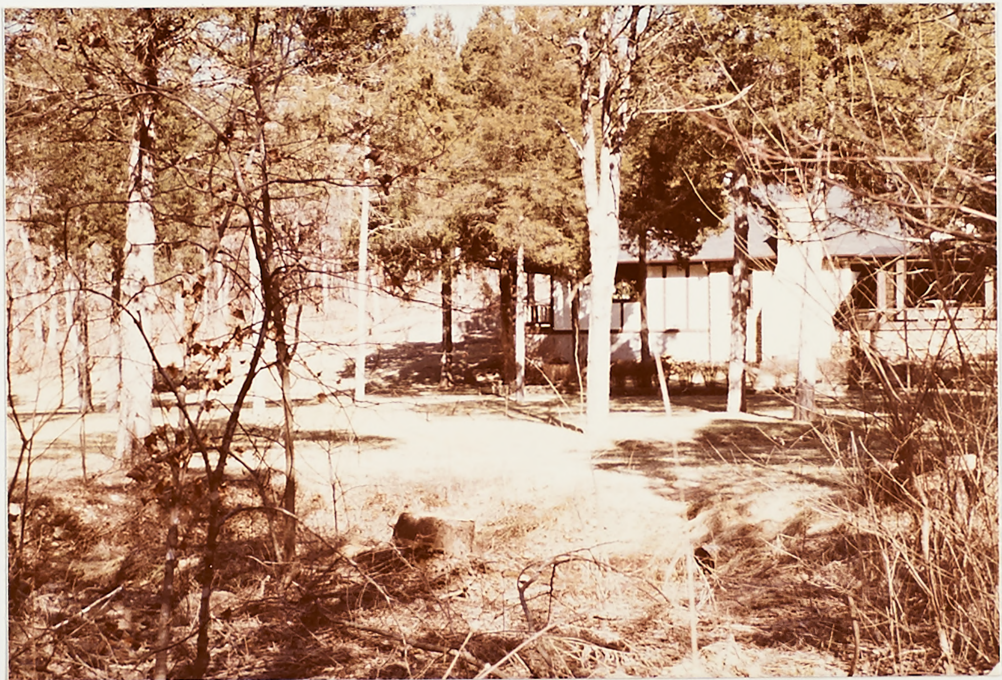
Photograph 13. View of dwelling located in the downstream hazard zone approximately 0.4 miles downstream of the dam. View is from the bank of the downstream channel.
